NEXT CHAPTER EQUITIES LLC

To: Orangetown Historical Areas Board of Review
20 Greenbush Road
Orangeburg, New York

As you may recall, we purchased the property located at 77 Main Street. (“Property”) in December, 2022 and appeared informally before the Historical Areas Board of Review (“Board”) in February, 2023 to obtain clarification as the Board’s scope of review, requirements, and procedures with respect to our proposed renovation and restoration of the Property. Since the time of our first appearance before the Board, we have retained an architect in connection with the rehabilitation of the property and done substantial due diligence on the current condition of the Property and what would be required to turn the Property into a first-class commercial property while maintaining the historic nature, look, and feel of the exterior. As we mentioned at our first appearance before the Board, the historic nature of the Property is what drew us to it in the first place.

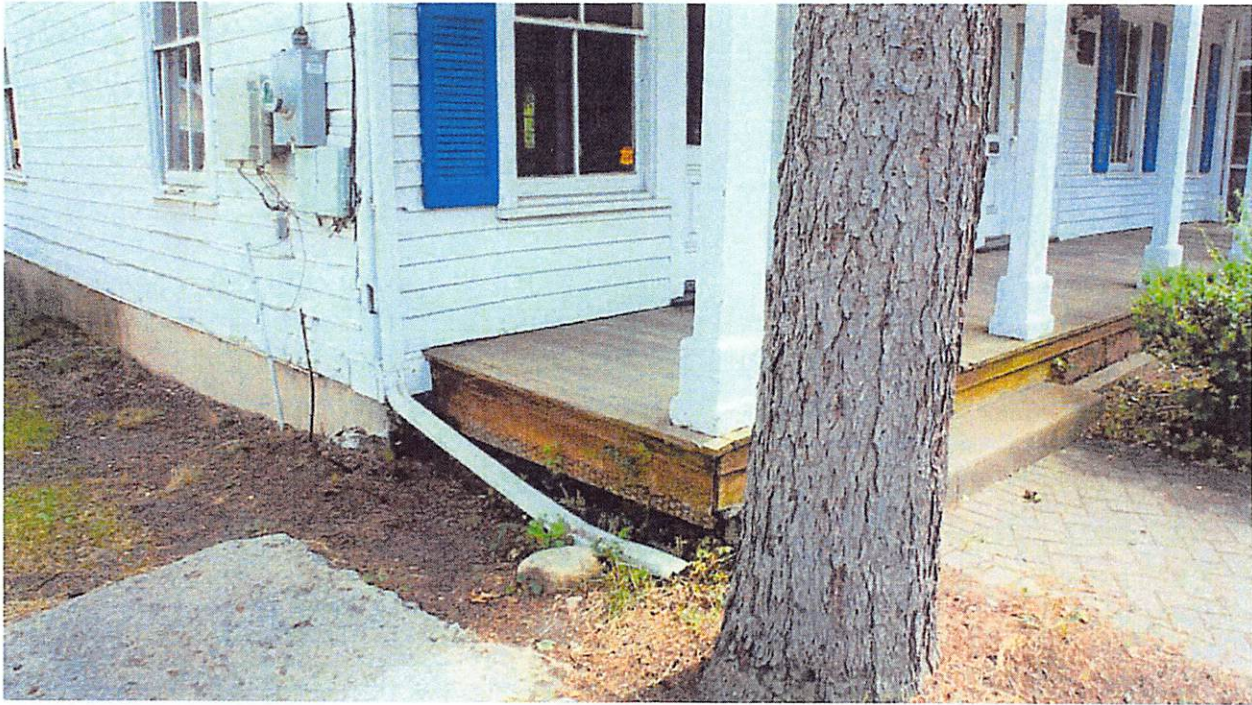
Cement Parging over bulging stone foundation at left (east) wall. Note inconsistent clapboard width from original front wall. We propose to rebuild this wall with concrete and use salvaged stone to build a new stone veneer wall to mimic what was originally there. We also propose to rebuild the wall and use 4" clapboard to match the front elevation.

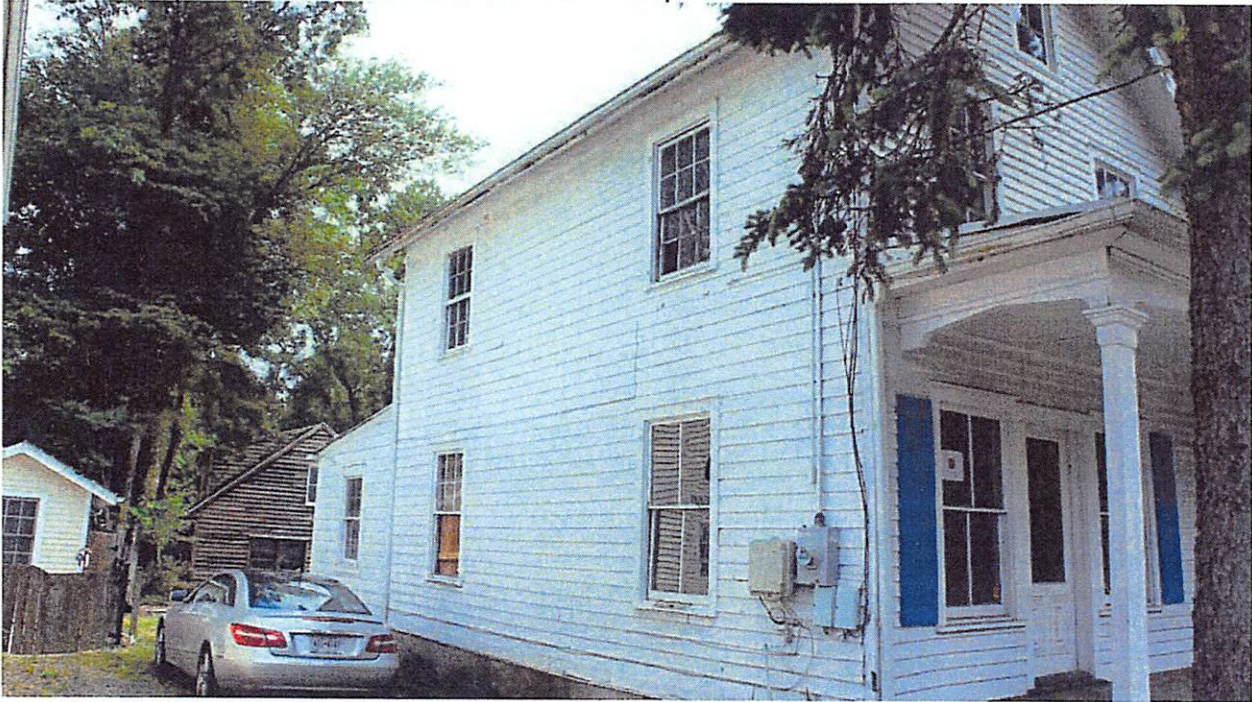
Will copy windows here with new simulated divided light windows. Note the inconsistent grill patterns of 2/2 (Victorian) and 6/6 (Colonial). We will present three options, one as is, one with 2/2 at first floor and 6/6 at second (like front has), and one with all 6/6 lites.

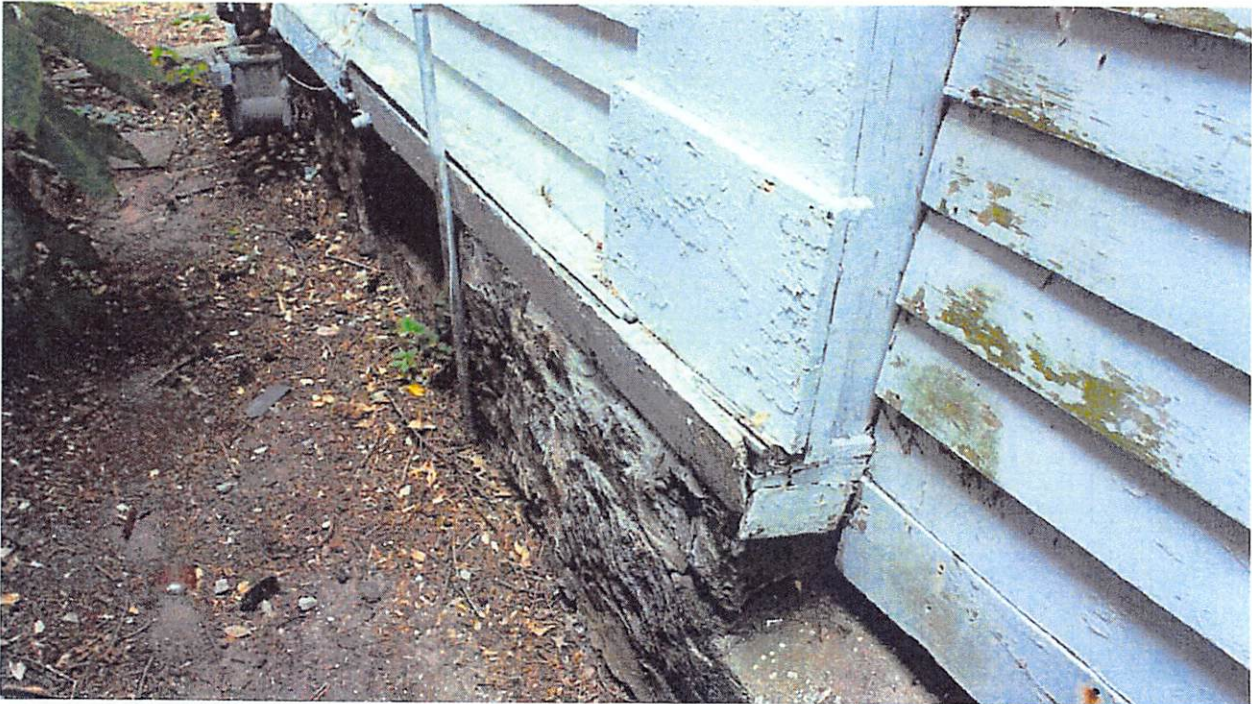
This photo shows the decaying sill plate which is causing the west wall to sink and become more unstable in the future. I propose reconstructing this wall with corner pilasters and 4" clapboard to match the front elevation. 2/3 of this wall will be demolished anyway since they were additions.

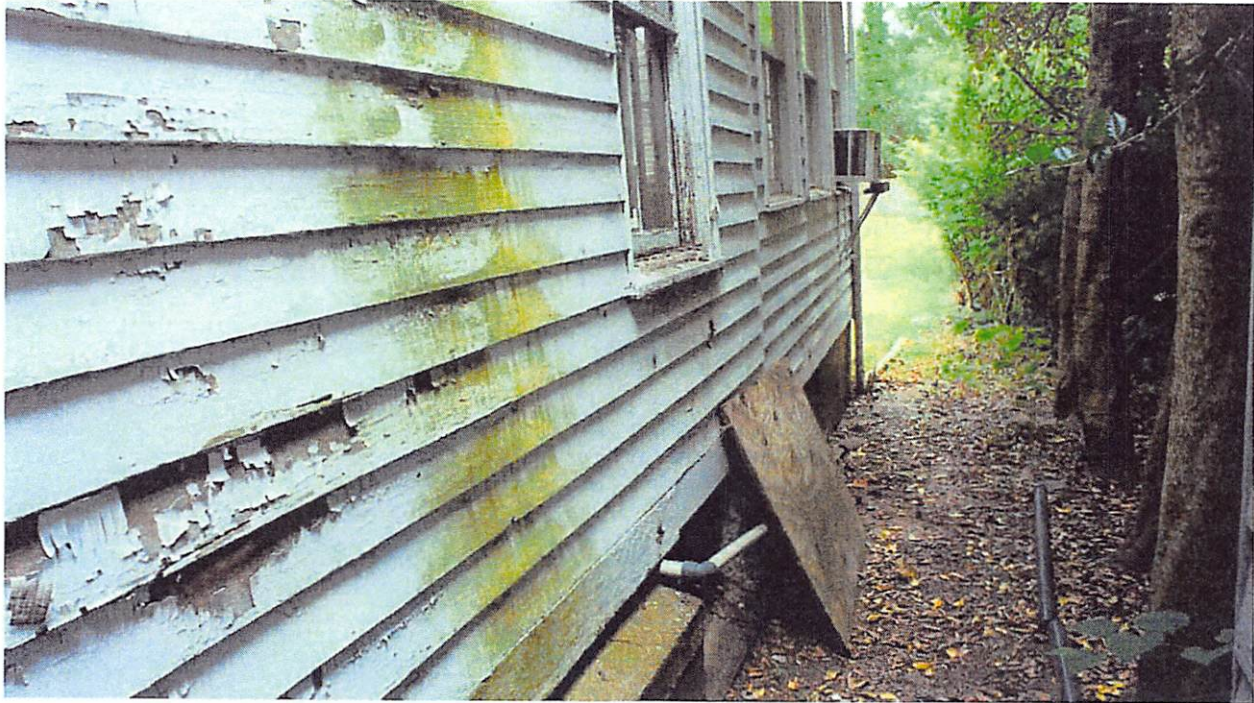
Here is the rear portion of the west wall to be demolished. One thing to note is that the west wall is located 4 feet away from the neighboring house and very little of it is visible from the street.

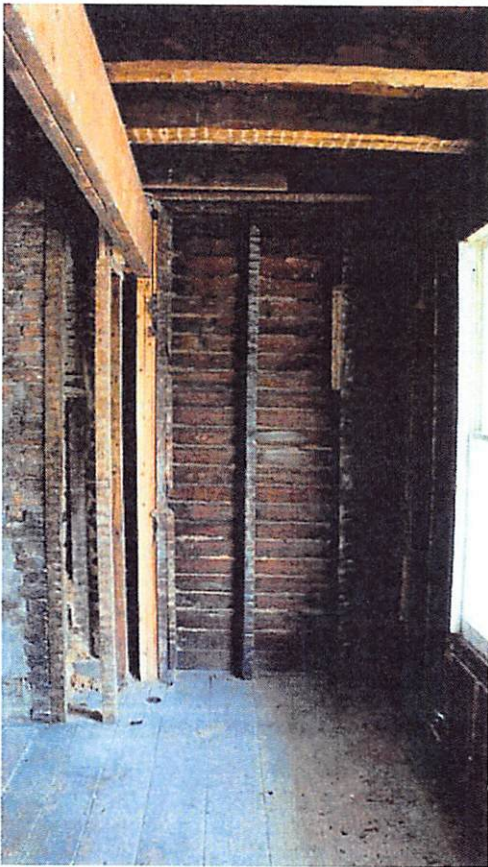
This photo shows the interior of the west wall. There are 2" x 4" wall studs at 36" o.c. spacing. The clapboard is nailed directly to them. This wall is structurally deficient, the mudsill is rotting and sinking, and there is no vapor barrier under the siding. We would like to demolish and reconstruct this wall with 4" clapboard on the exterior to match the front wall.

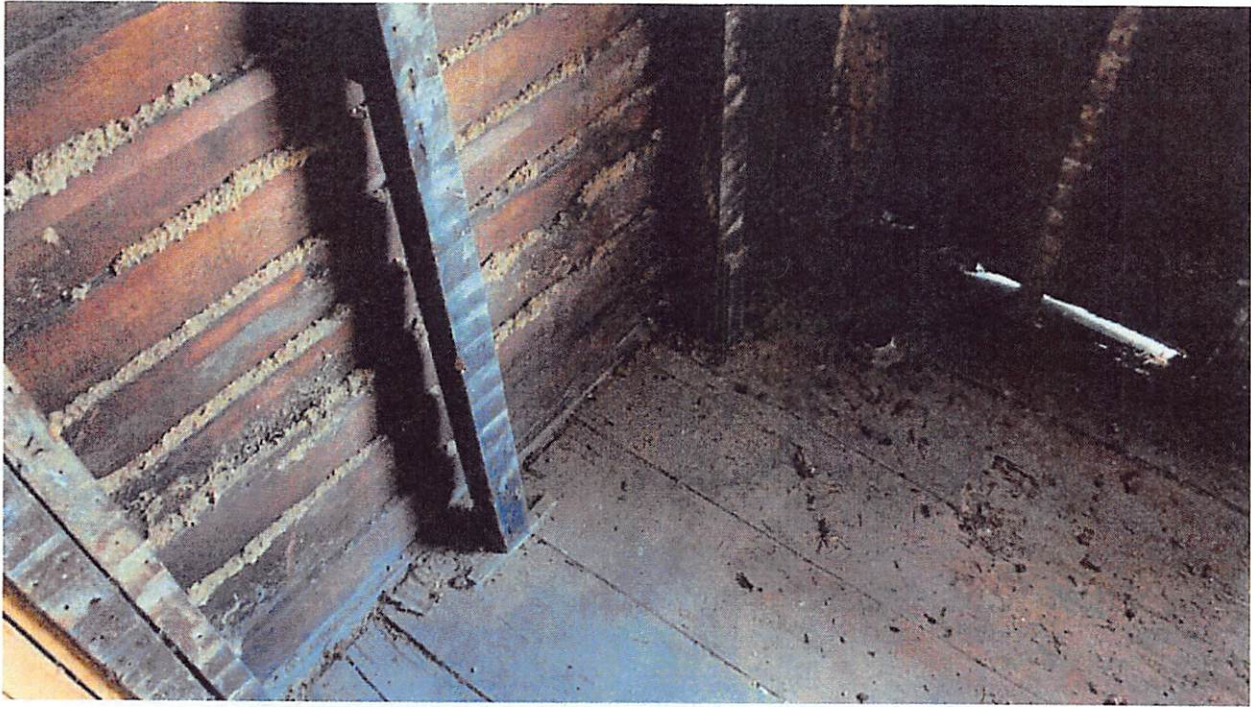
Here is a closer look at the west wall construction from inside. Note the daylight coming from under the north wall. Although not visible here due to old cellulose insulation blocking it, there is daylight coming in between the exterior clapboards as well in many locations.

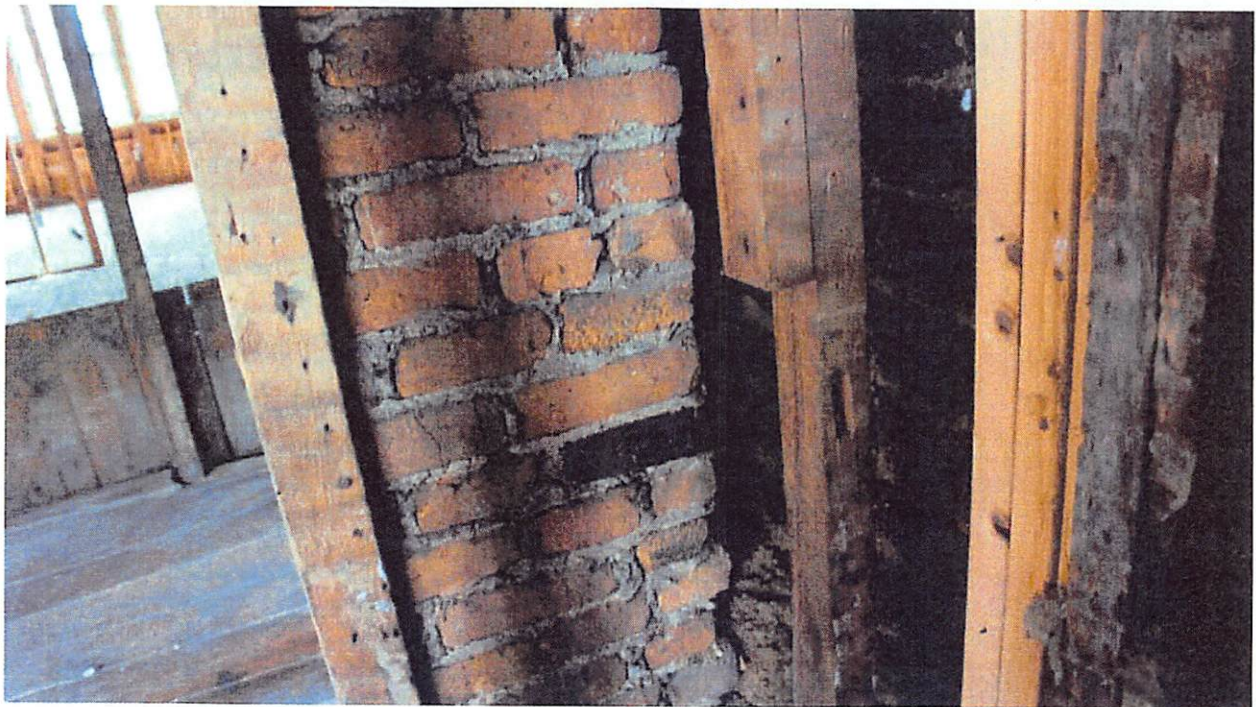
This is an abandoned brick chimney that is structurally unstable and does not have proper support in the basement. We propose removing this. It is not a significant architectural element from the street and is barely visible mainly due to the large pine tree in front.

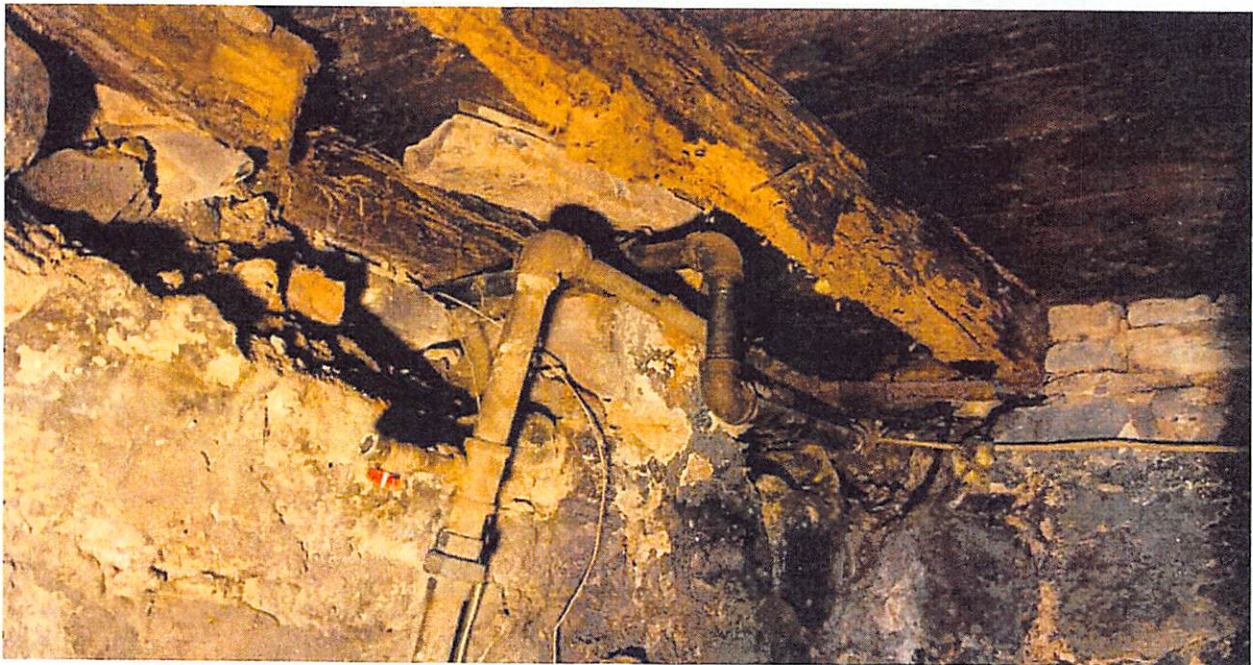
All joist ends bear on the stone foundation walls directly. Because of this, many are rotting. The only way to replace these is to install new joists on beams with footings with lally columns. In addition there is no good way to tie the new floor structure into the damp and rotted wall framing and joist ends on the foundation. Demolishing the exterior walls and constructing a new foundation will be better for longevity and structural soundness.

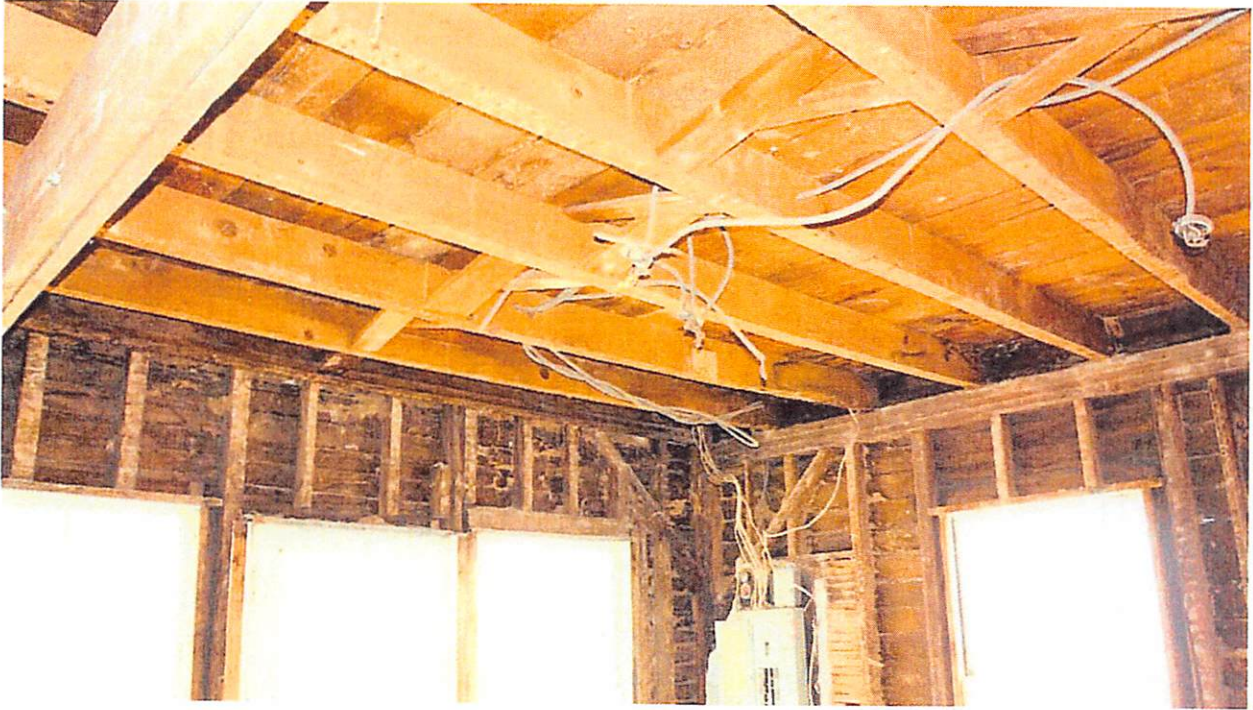
The east foundation wall (under right side wall in photo) has settled approximately 2" which creates a slope in the floor in addition to the sagging. The joists at this floor are 3" x 7" at 24" on center spanning 16 feet. They, and all joists, are seriously deficient. A beam was previously added to prevent collapse but this has not addressed any of the floor issues.

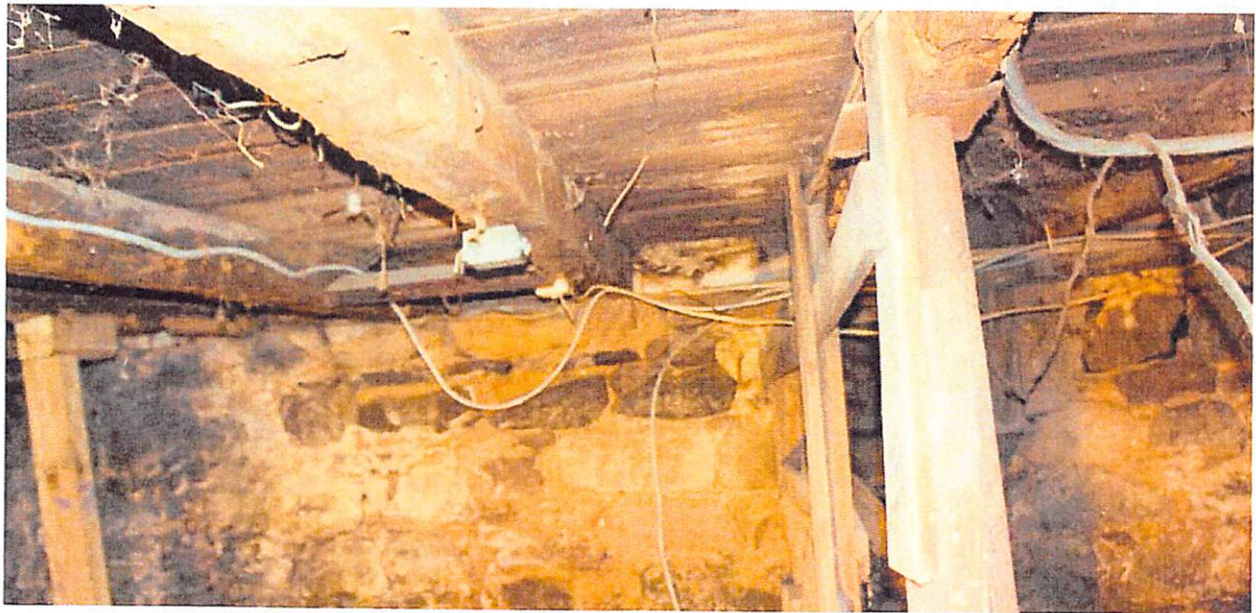
The original portion of the house (northwest quadrant) has a 20" wide stone foundation which does not have footings. There is some structural settling of about 2" present in some areas. There is 5' of headroom in the cellar here. Since the walls and floor have no waterproofing there is constant moisture and standing water in the basement even with two sump pumps existing.

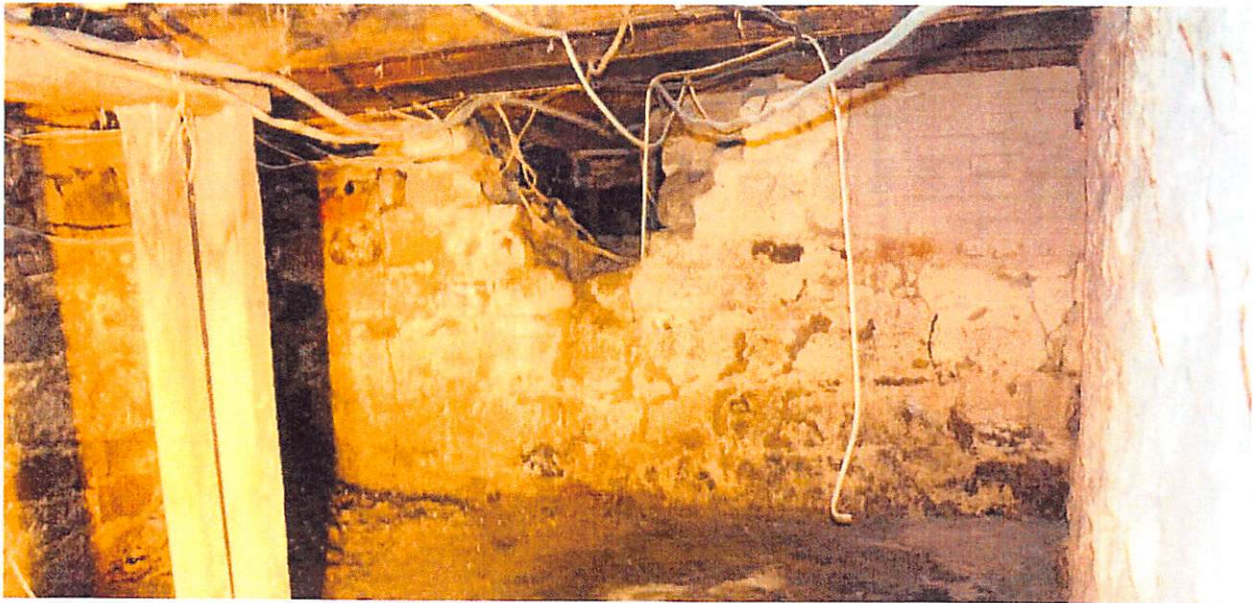
This is the wall separating the original cellar from the crawl space added added at the northeast side. The existing slab needs to be replaced in order to install french drains and a vapor barrier on gravel. As noted on page 5, a network of footings, columns, and beams needs to be added to support the new joist ends as we can't bear them on the stone. This creates an issue with lateral support at the stone wall which will be difficult to remedy.
