**PHASE IA LITERATURE REVIEW
AND
ARCHEOLOGICAL SENSITIVITY ASSESSMENT**

**THE FOUR SEASONS AT ORANGETOWN
TOWN OF ORANGETOWN
ROCKLAND COUNTY, NEW YORK**

HAA 4127-11

AUGUST 2008

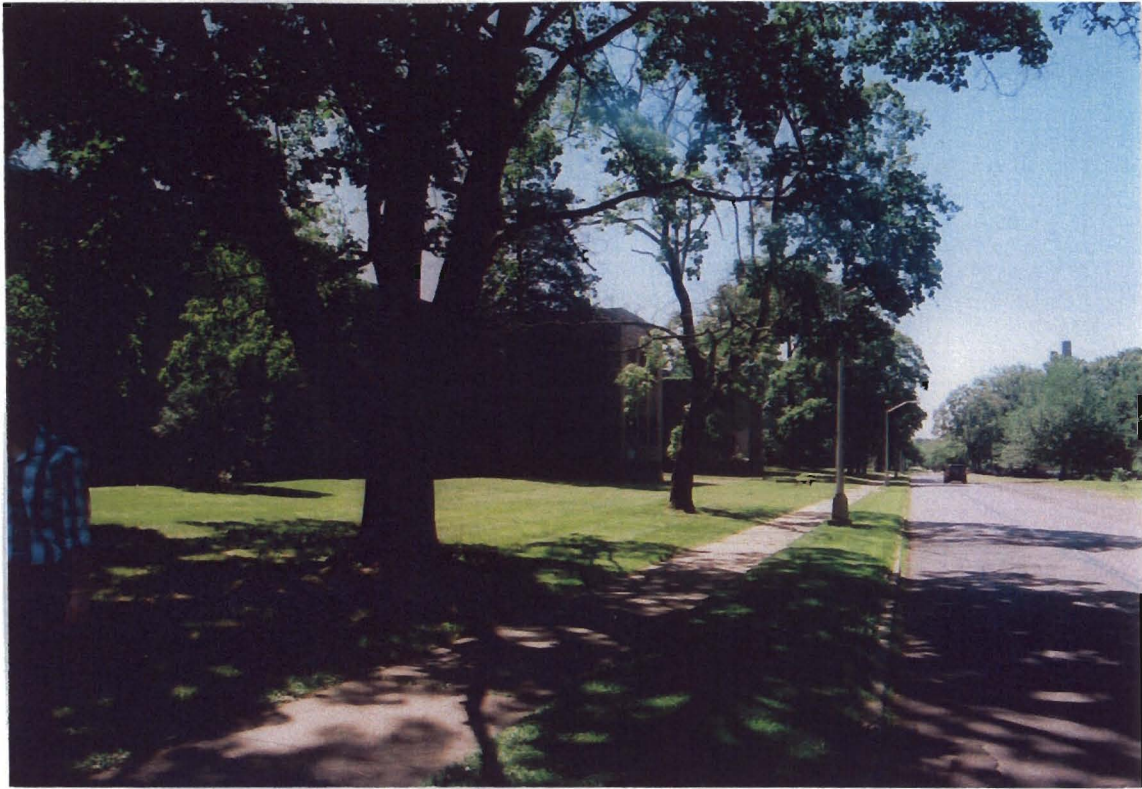
PHOTO 1: View south of the sidewalk, road and buildings 34 and 36 located within the northwestern portion of the project APE. The National Register Eligibility site form indicates the structures were constructed in 1930 and served as patient housing and for patient services.

The western portion of the APE contains several hospital building clusters with courtyards, sidewalks and service roads (Map 2; Photos 1, 2, and 3). The buildings are connected by a series of underground service tunnels. A small wooded area adjoins the westernmost service road and another wooded area occupies the north end of the complex (Map 2; Photos 4 and 5). The outdoor pool that is indicated on the 1967 USGS map (Maps) at the north end of the complex has been buried and is now lawn area (Map 2; Photo 6).

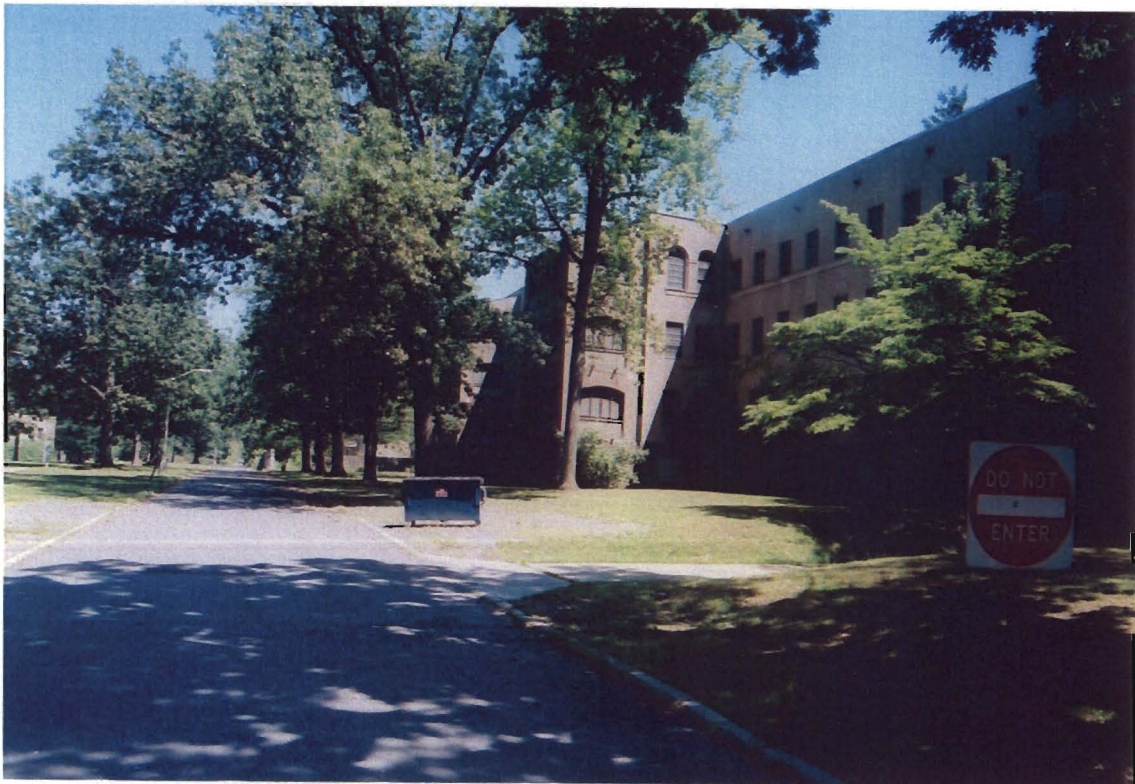
PHOTO 2: View north of the road and buildings 4, 7, and 8 located within the west central portion of the Psychiatric Center complex. The buildings were built in 1927 and used for medical services and as dining rooms and clinics.

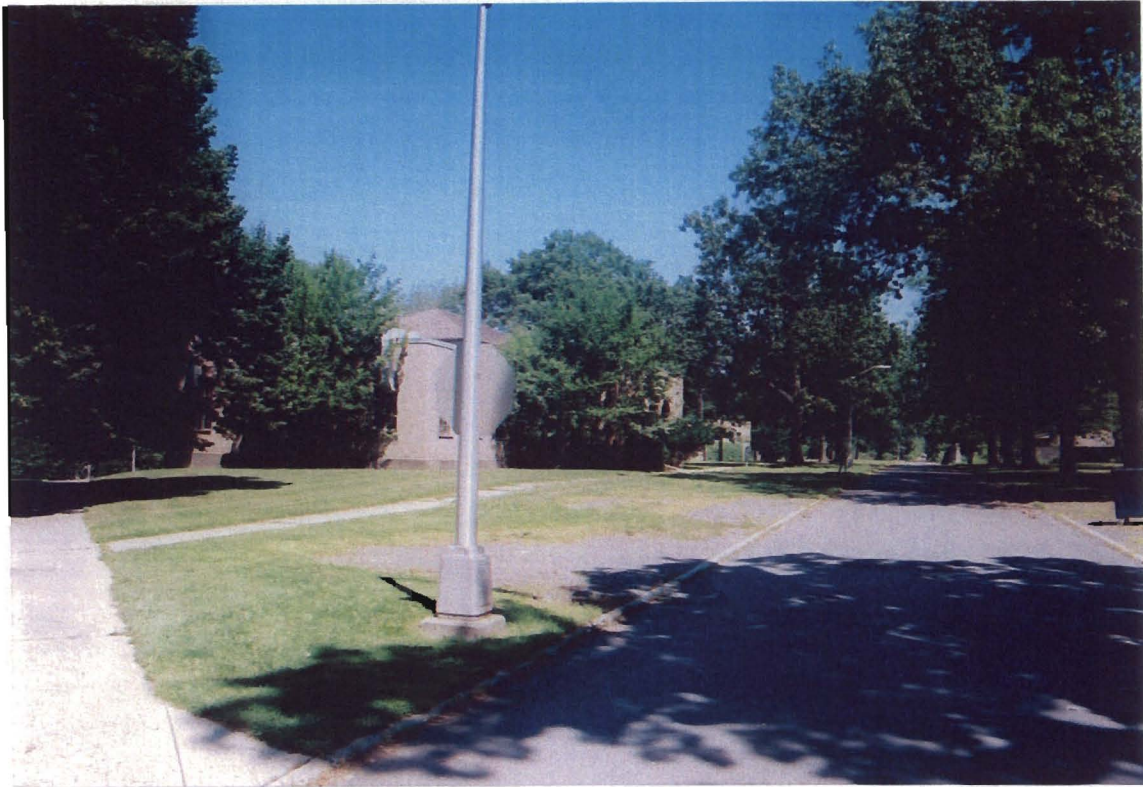
PHOTO 3: View north of the road, sidewalks and buildings 14 and 85 located within the north central portion of the project APE. The buildings were constructed in 1927 and 1933 and functioned as offices for administrative staff.

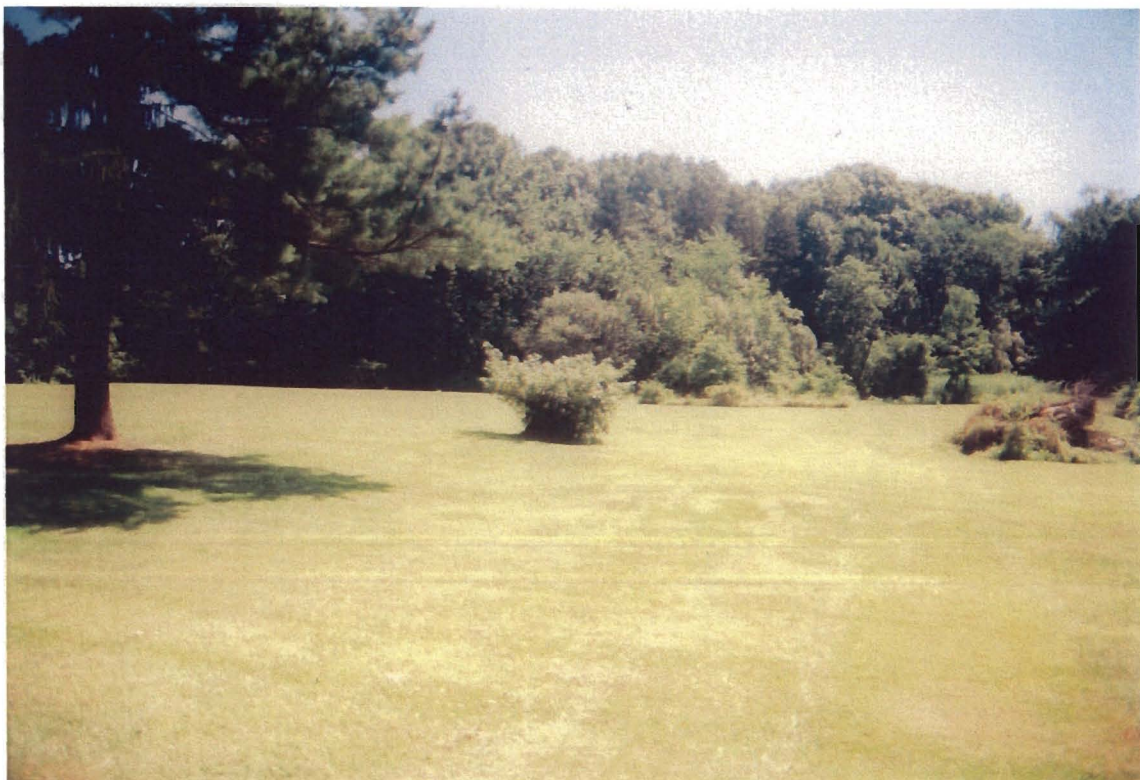
PHOTO 4: View east of the wooded area located at the northern end of the project APE. The area is considered sensitive for precontact cultural resources and subsurface testing is recommended for this section of the project APE.

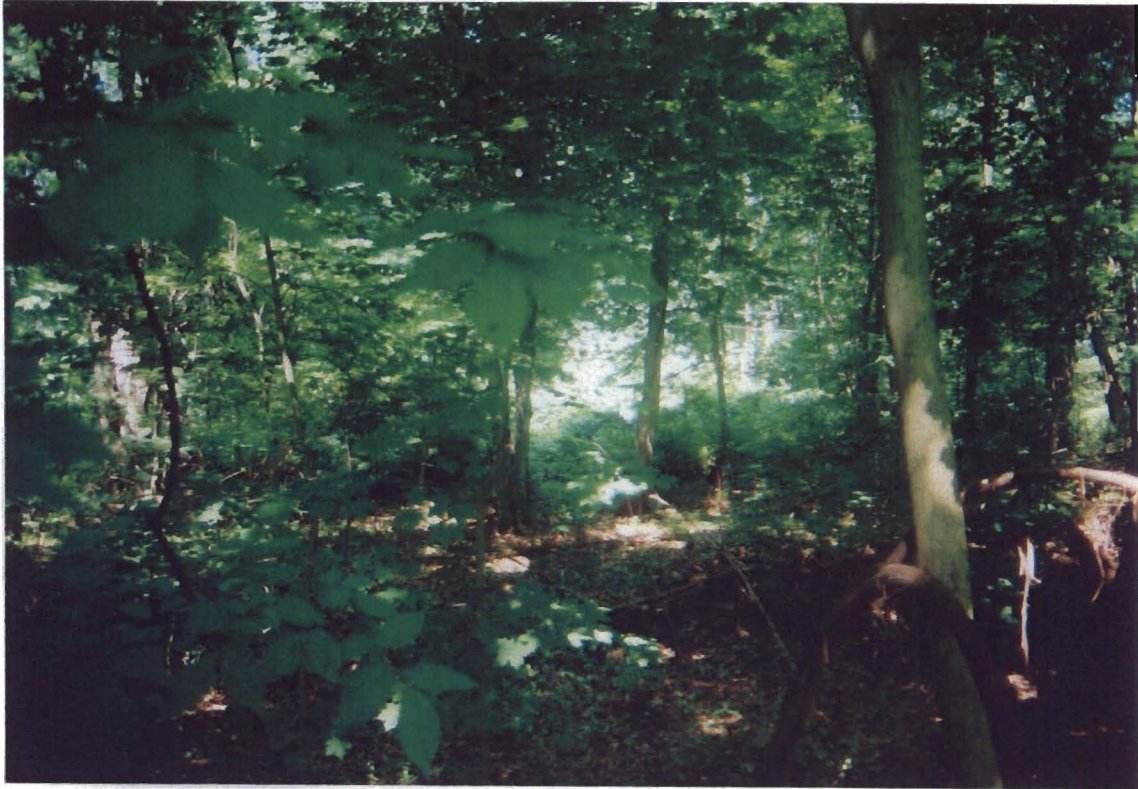
PHOTO 5: View east of a wooded area located along the western edge of the project APE. The wooded areas are considered sensitive for precontact cultural resources and subsurface testing is recommended for the level to moderately sloping and dry sections.

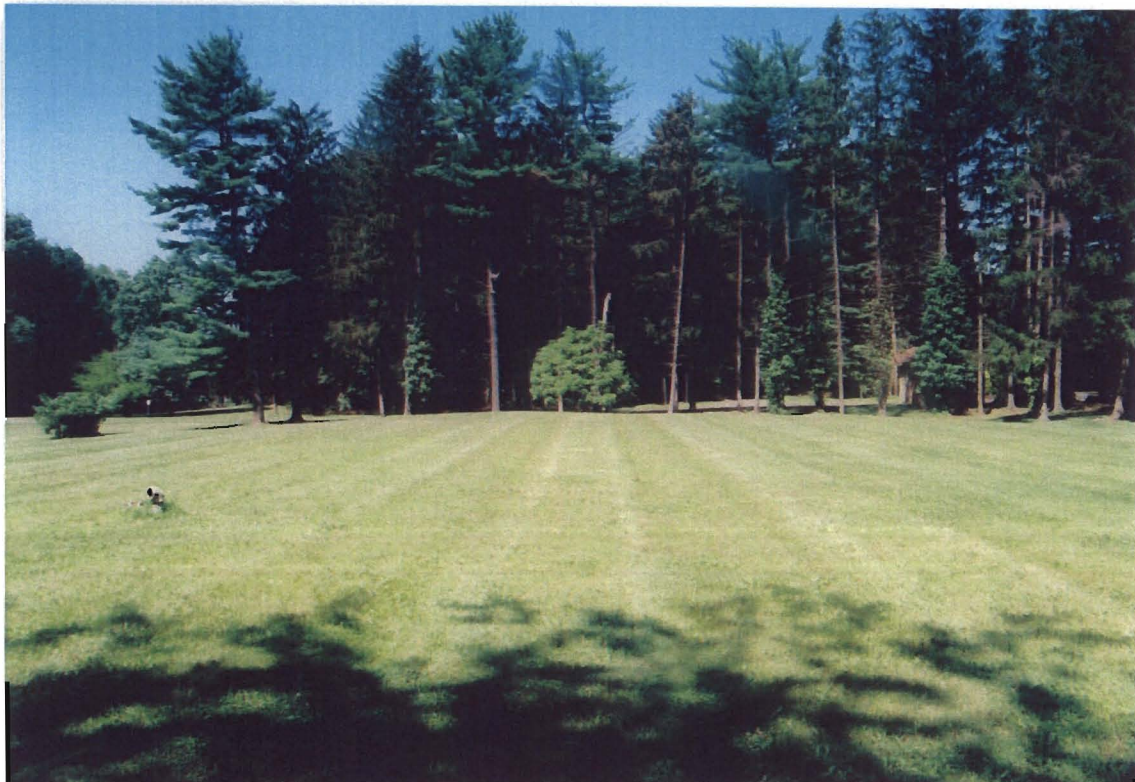
PHOTO 6: View west of the old pool foot print located at the northern end of the project APE. The area has experienced soil disturbance resulting from construction and removal of the swimming pool.

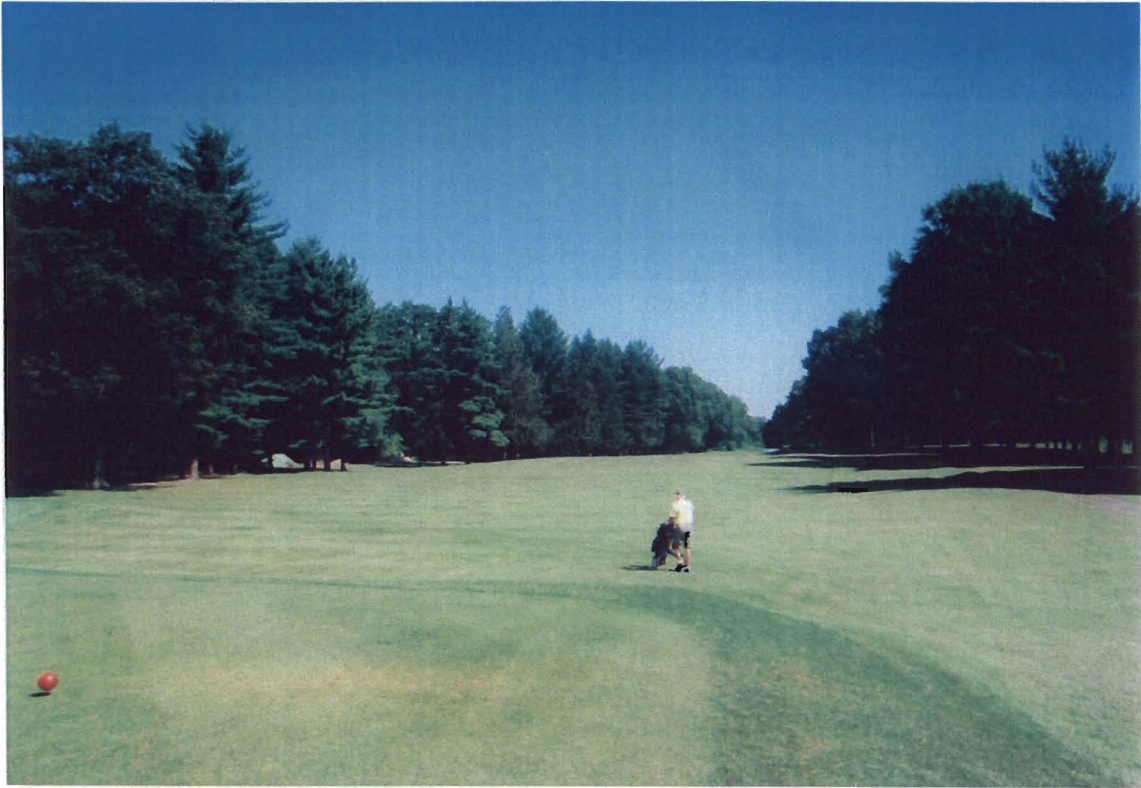
PHOTO 7: View north of the first hole fairway located east of the Psychiatric Center complex. The wooded area between the fairway and the complex is considered sensitive for precontact cultural resources and testing is recommended for this area.

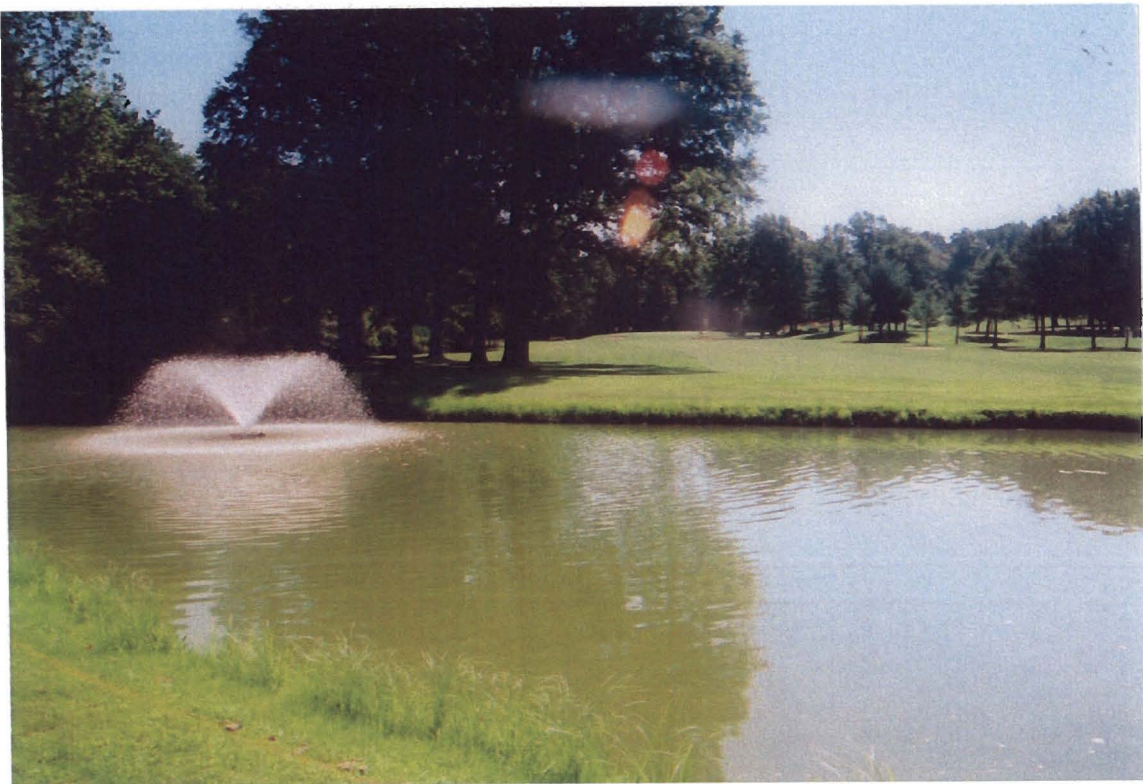
PHOTO 8: View east of the pond and second hole fairway located within the northeastern portion of the project APE. The wooded areas parallel to the fairway are considered sensitive for precontact cultural resources and subsurface testing is recommended.

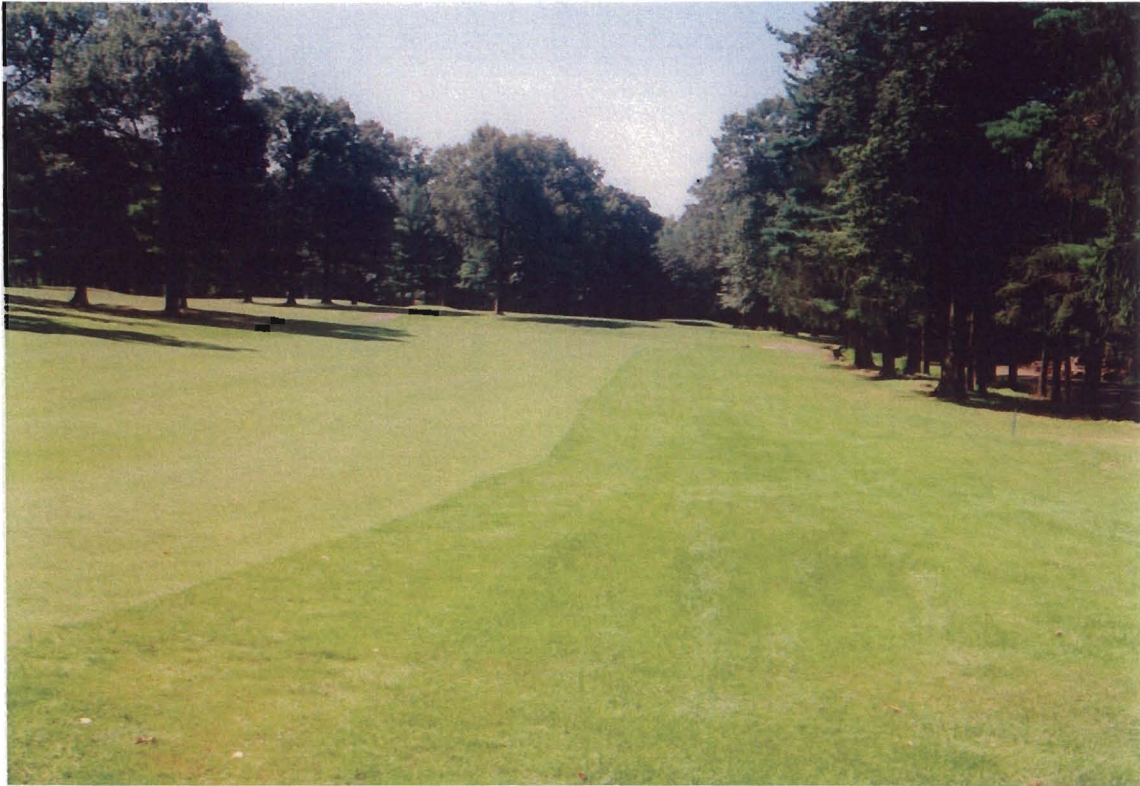
PHOTO 9: View south of the fairways and wooded areas situated within the southern portion of the golf course. The wooded areas parallel to the fairways are considered sensitive for precontact cultural resources and subsurface testing is recommended.

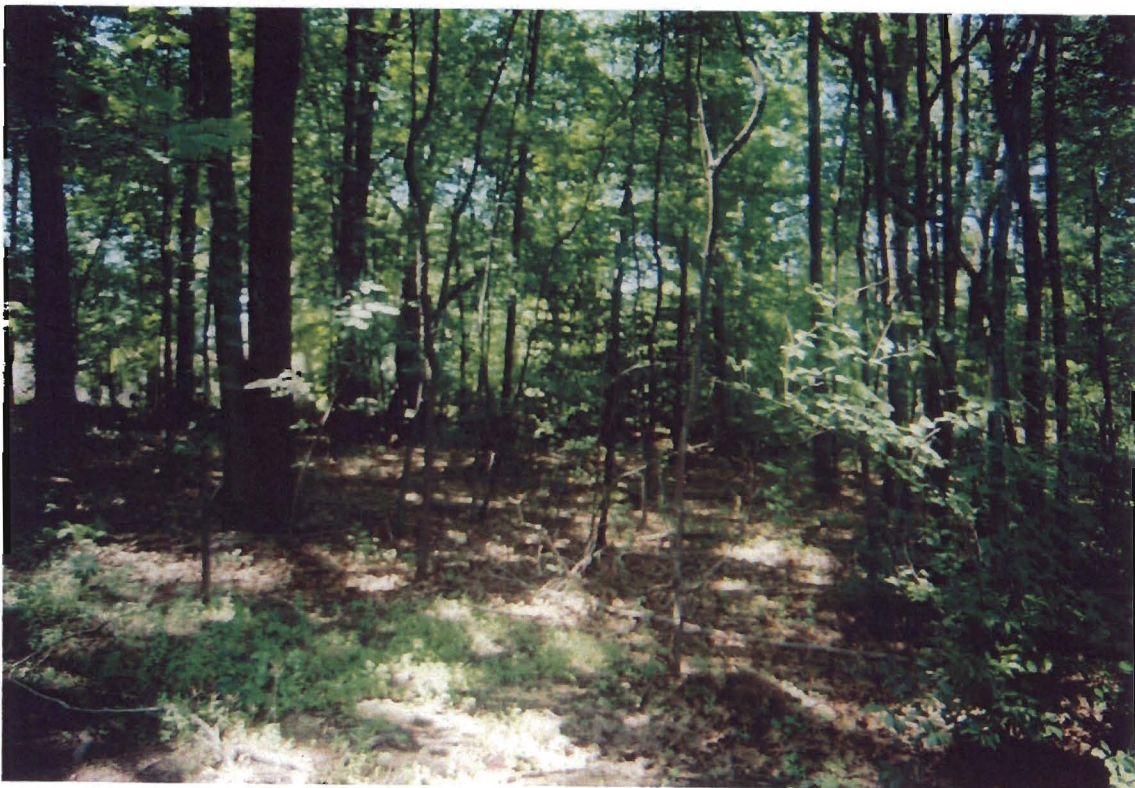
PHOTO 10: View north of the wooded area situated north of the golf course parking lot. This area is considered sensitive for precontact cultural resources and subsurface testing is recommended for the level to moderately sloping and dry sections.

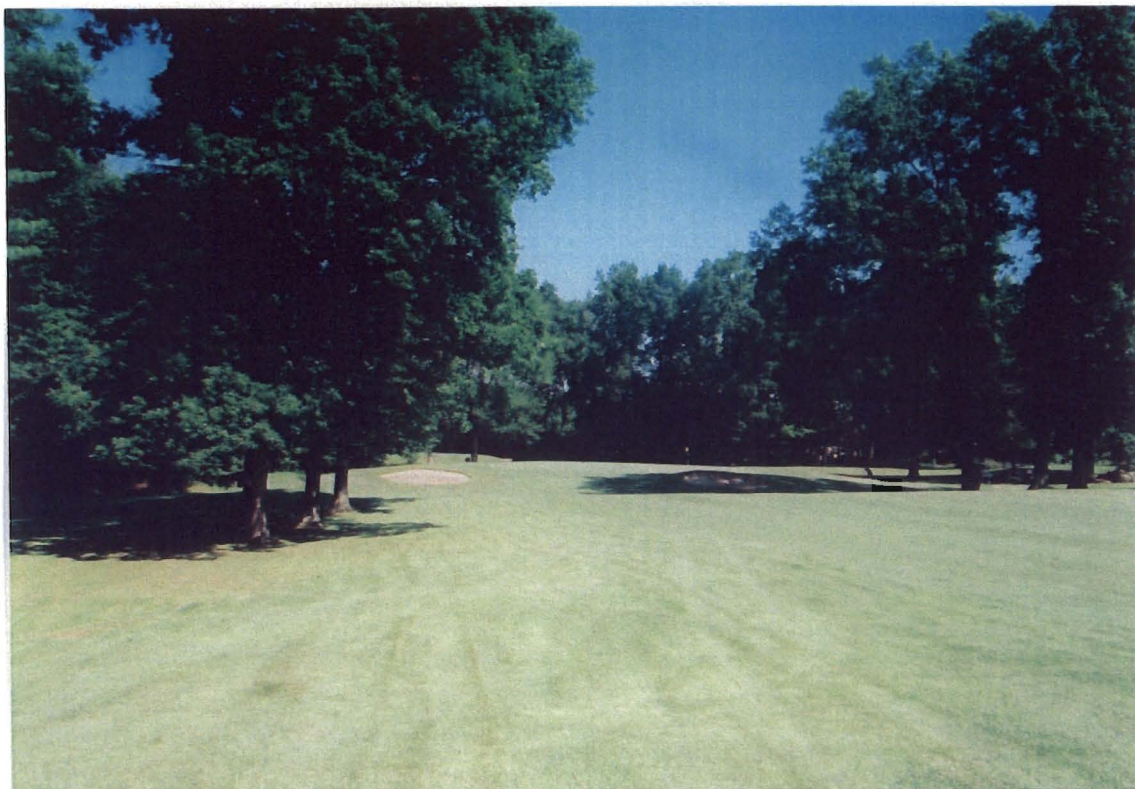
PHOTO 11: View south of the fourth hole fairway and green located at the southern end of the golf course. The wooded area south of the green is considered sensitive for precontact cultural resources and subsurface testing is recommended for this area.

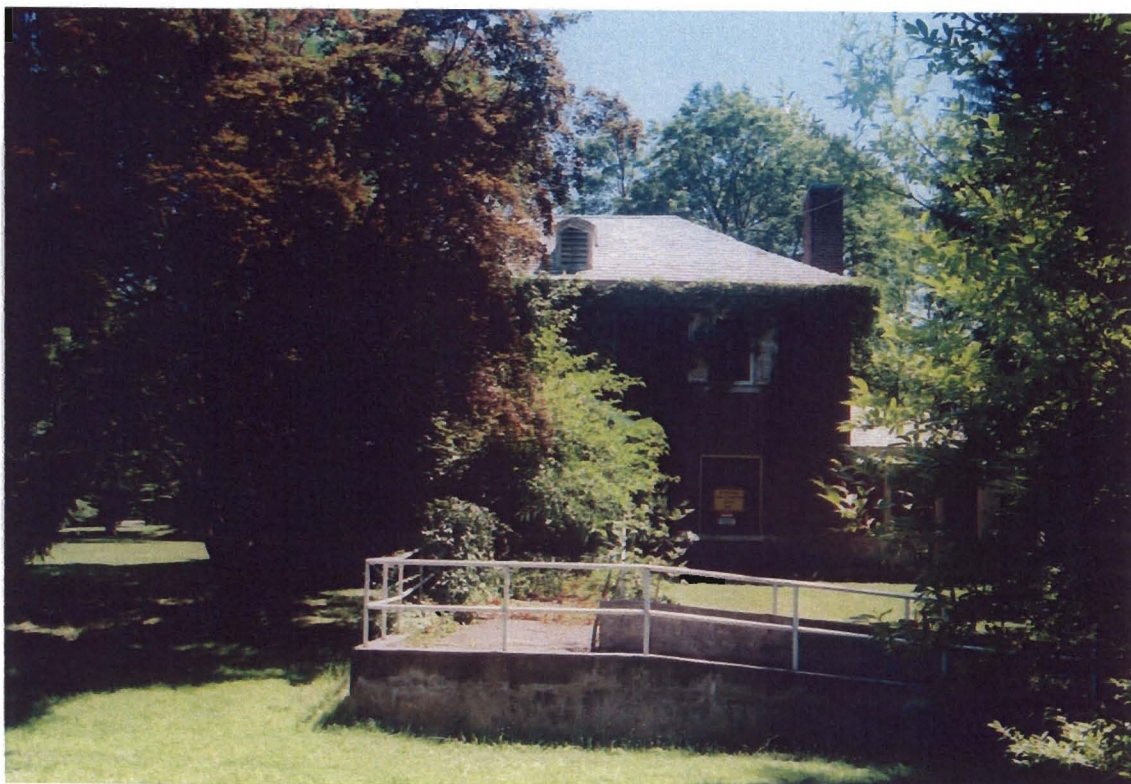
PHOTO 12: View southwest of building 52 located along the south side of Old Orangeburg Road within the southern portion of the APE. The structure is not listed in the building-structure inventory.

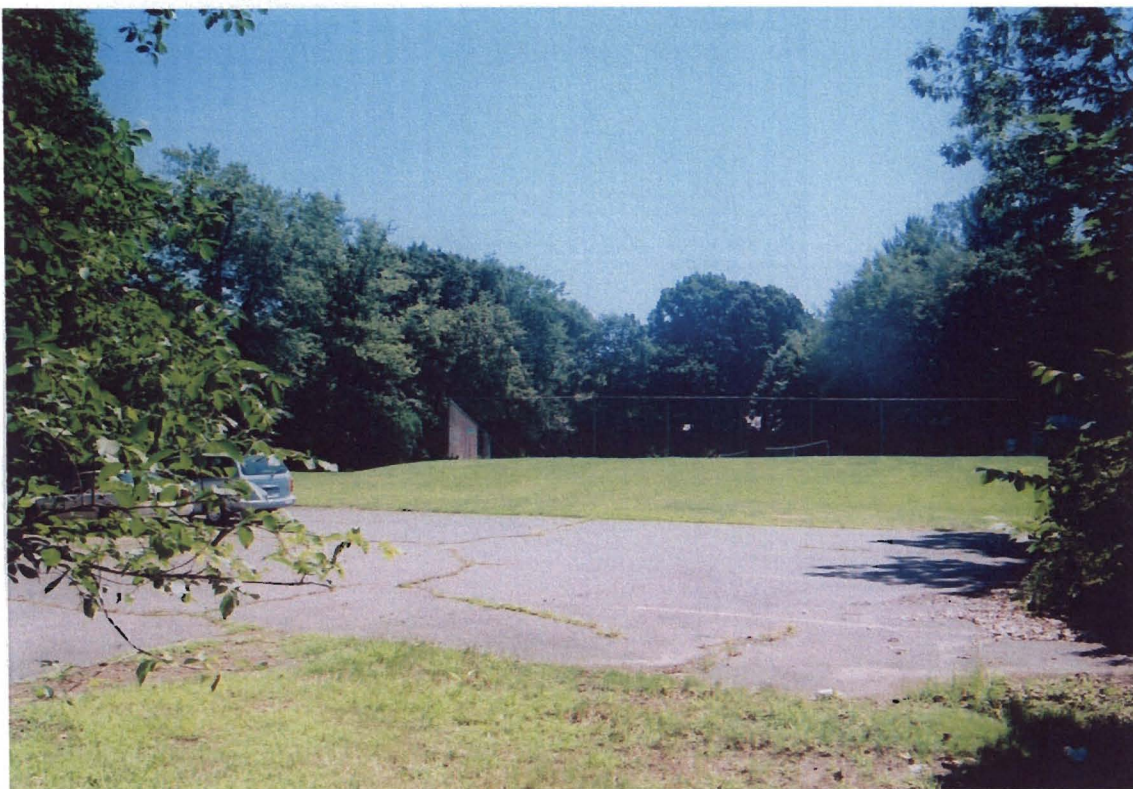
PHOTO 13: View east of the parking lot, tennis courts, and a small wooded area encompassing the southern portion of the APE. The wooded area is considered sensitive for precontact cultural resources and testing is recommended for this area.

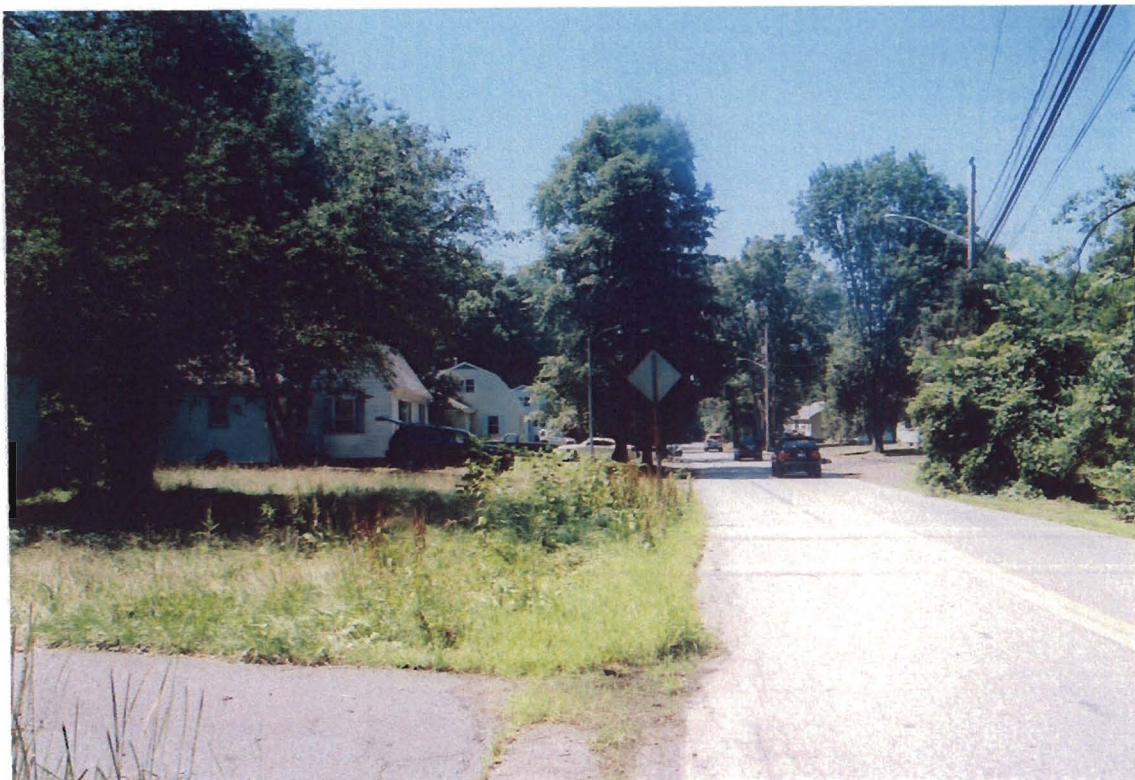
PHOTO 14: View south of the buildings situated along both sides of Blaisdell Road. Most of the buildings served as staff housing and were constructed during the 1950s and 1960s.

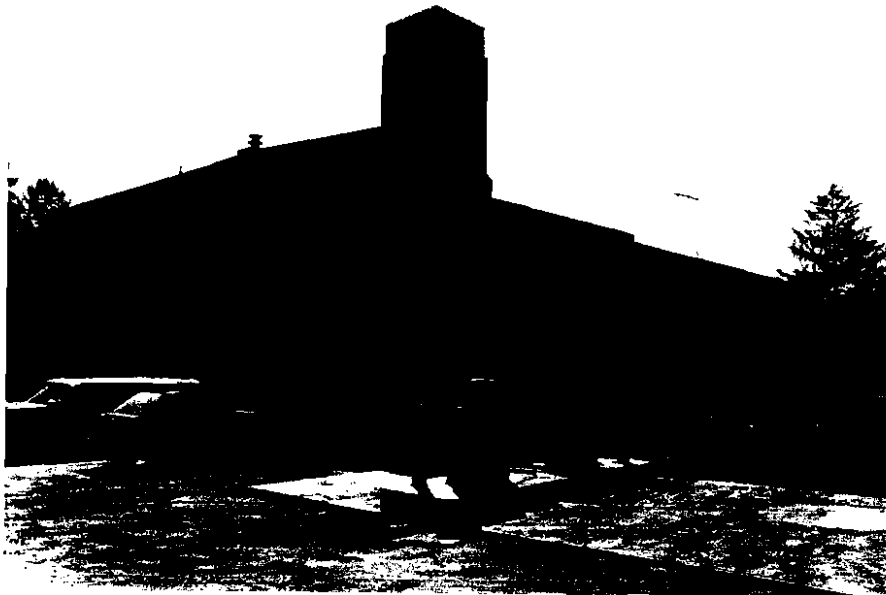
Rear elevation

The side elevations show three groups of windows like the facade on the second floor and three groups on the first floor without sill or lintel decoration. The raised foundation (visible on the side elevations) is of coarse rubble concrete. The basement windows are 1/1 horizontally opening. On both side elevations the single rear bays project slightly with one bay on each floor as above.

A square section, castellated tower projects from the southwest corner of the central block with single, round, multi-light windows on each elevation near the top.

The roof of the main block is capped by a tiled roof ventilator positioned at the ridge pole near the facade.

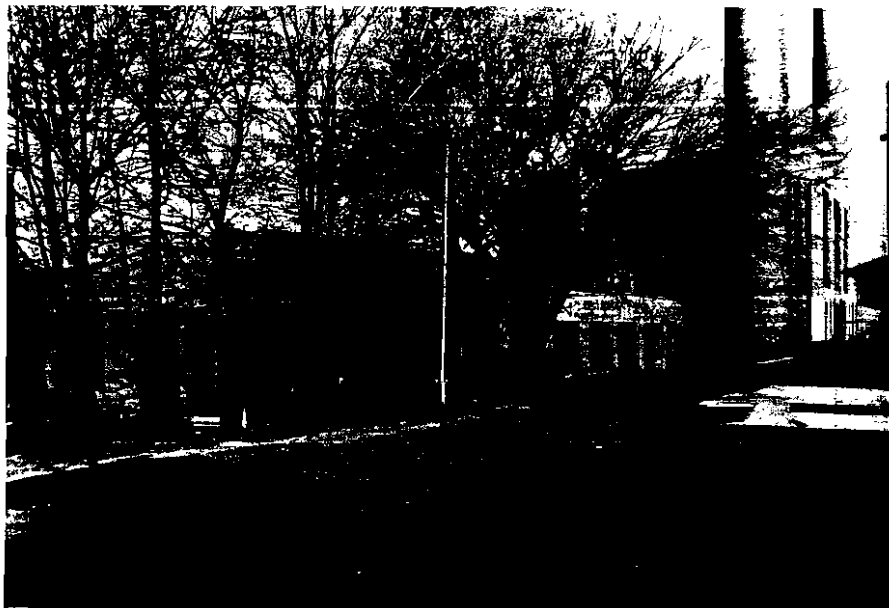
South addition

A one story wing extends to the south. This section has a flat, capped,parapet roof with a raised central clearstory; is ten bays long and is made of stucco. Each bay contains a large, multi-paned, metal casement. The clearstory area has a continuous run of multi-paned casements and vents.

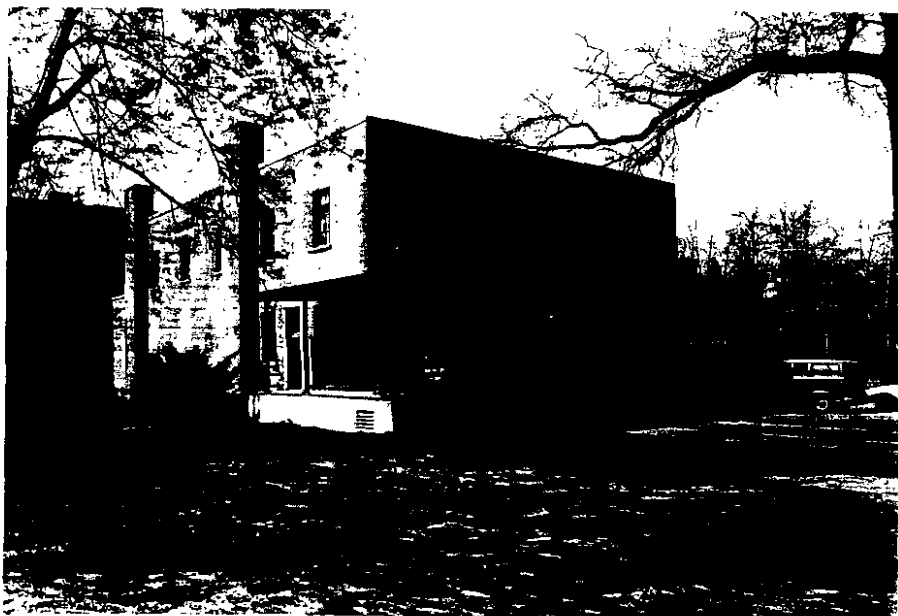
Rockland Psyc. Center
Cont. sheet, bldg.45

18. under a flat roof canopy. The second floor has paired 2/4/2 flanking paired 2/4/2 X 2/4/2 windows. The loading dock and canopy extend to the east elevation.

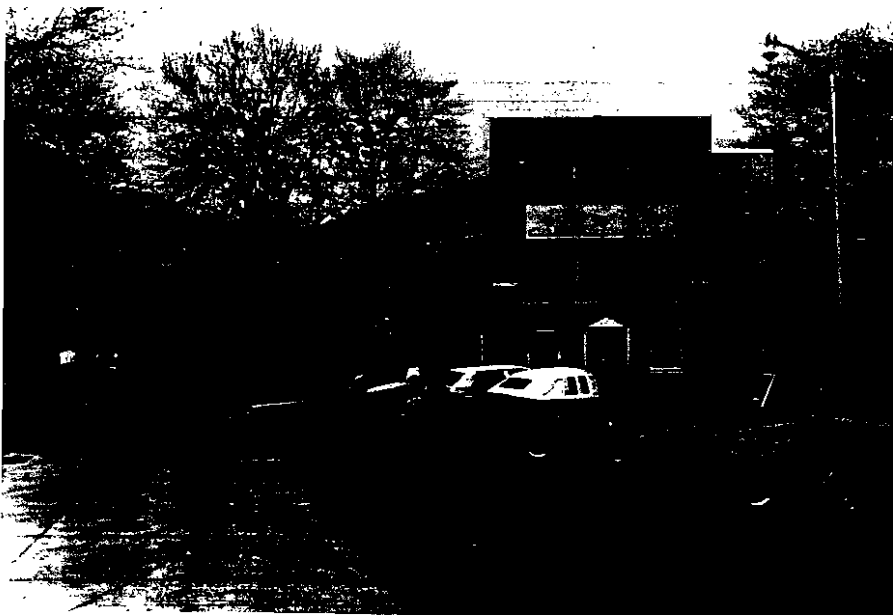
Southwest elevation

18. balcony at the second floor level. The balcony frames a large second story window of opaque glass bricks in a slightly recessed stucco reveal. The main entrance is flanked by two 4/4 horizontal windows in stucco reveals flanked by engaged pilasters and an additional horizontal 4/4. The second floor has two large multi-paned windows flanking the central glass brick area flanked by engaged pilasters and a horizontal 3/3 window. The third story shows a central 3/3 horizontal window flanked by three 3/3 horizontals to each side, engaged pilasters and two additional 3/3 horizontal windows. Windows on the third floor rest on a concrete beltcourse and use the simple concrete cornice as lintels. Windows on the lower floors have no apparent sills or lintels.

The projecting "X" wings are two story with flat capped parapet roofs and have eleven bays of 3/3 horizontal windows. The first floor windows in these sections rest on a concrete watertable as do those across the facade of the central block. The side elevations of the wings are three bays wide and employ tubular roof drains.

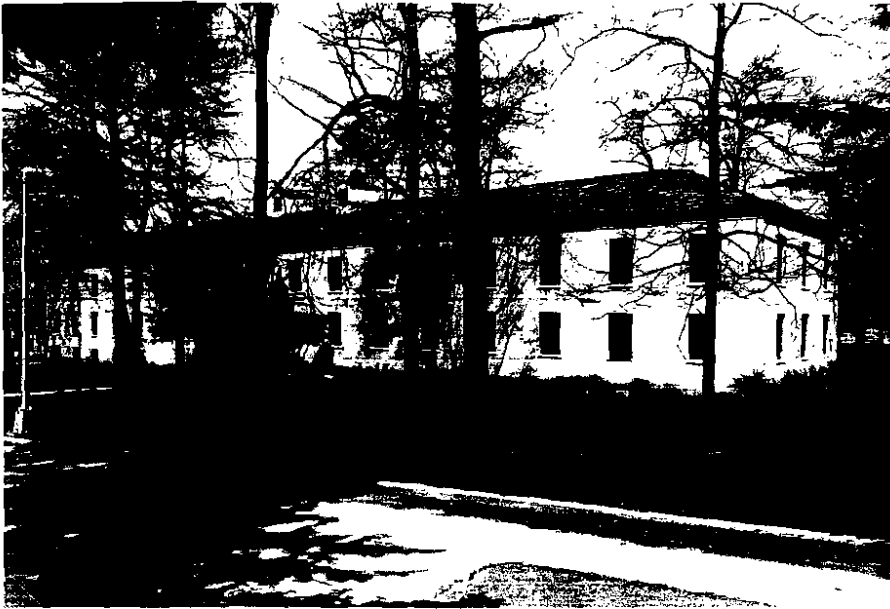
Bldg. 31

18. surrounded by plain concrete cornices.

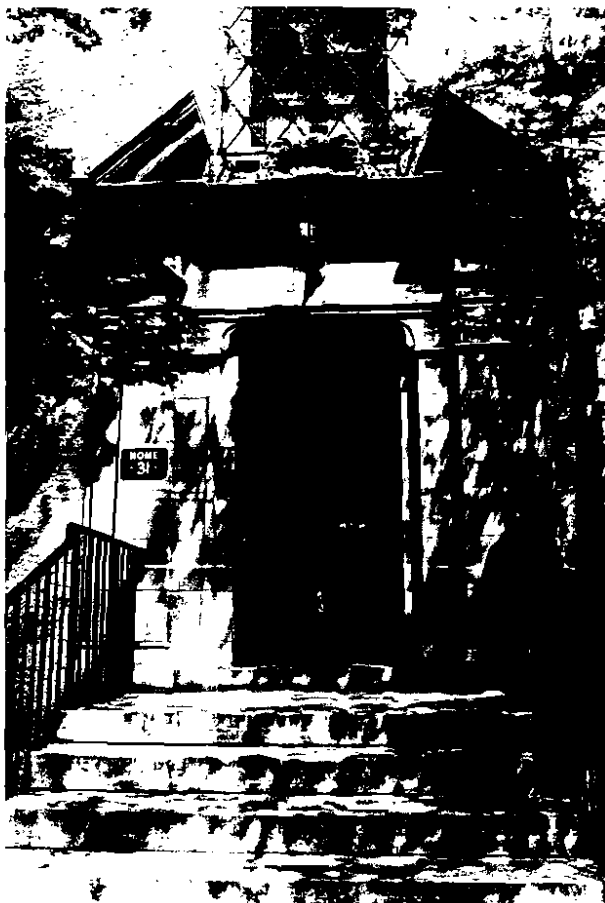
Bldg.31 Doorway detail

The central entrance bay projects slightly and has 4/4 windows on the second floor with wrought iron grate screens. The entrance door is glazed and panelled and set into a sandstone surround. Flanking the door are stylized columns of square section with elaborate Corinthian capitals flanking central masks which all support a fully developed classical cornice under a panel of cast dolphins under an egg and dart moulded cornice which supports a broken pediment with central shell cartouche. The door is flanked by recessed blocking with foliate decoration in the upper corners.

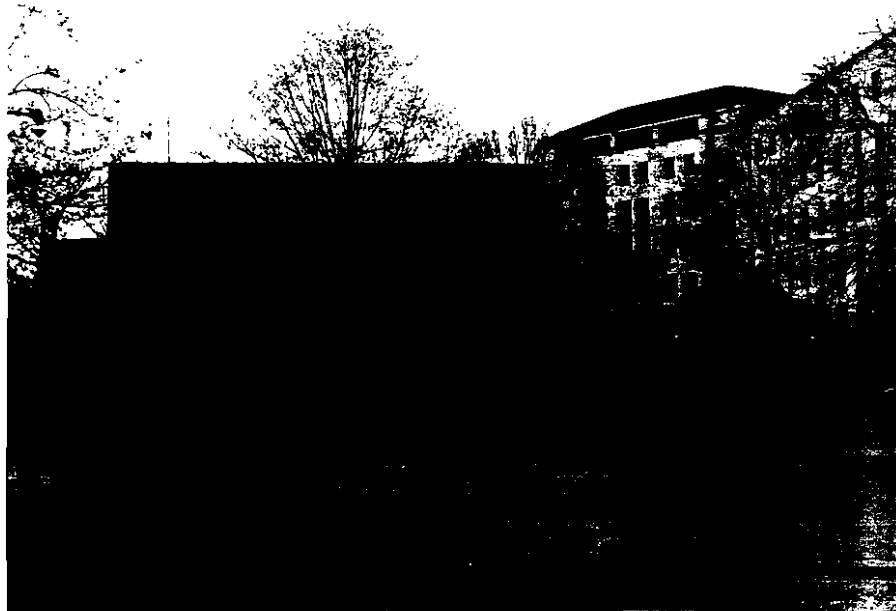
Bldg.58 looking west

18. windows. The massive sixteen bay wings which connect the end bays to the central core have windows like the end bays.
- The central block is eight bays wide and shows pairs of 42 light windows in the central six bays and single 30 light windows in the flanking end bays. Above the top floor in the central section are moulded roof vents which employ an eclectic assortment of Classical details including fluted pilasters, modillion blocks and cast shells. The main entry door to the building is located in the center of the main block. The door itself is elaborately panelled and has an overdoor of cast shell and foliate decoration set into a brick surround mounted on a shallow vestibule with a tile roof.

20. earlier style designs. Essentially, what one sees in the hill complex are high rise towers that employ baroque and/or Mission Style decorative motifs generally in a stylized manner to produce buildings that stylistically relate to the earlier structures at Rockland Psychiatric. This complex is certainly unique in the Hudson Valley and probably in the State.

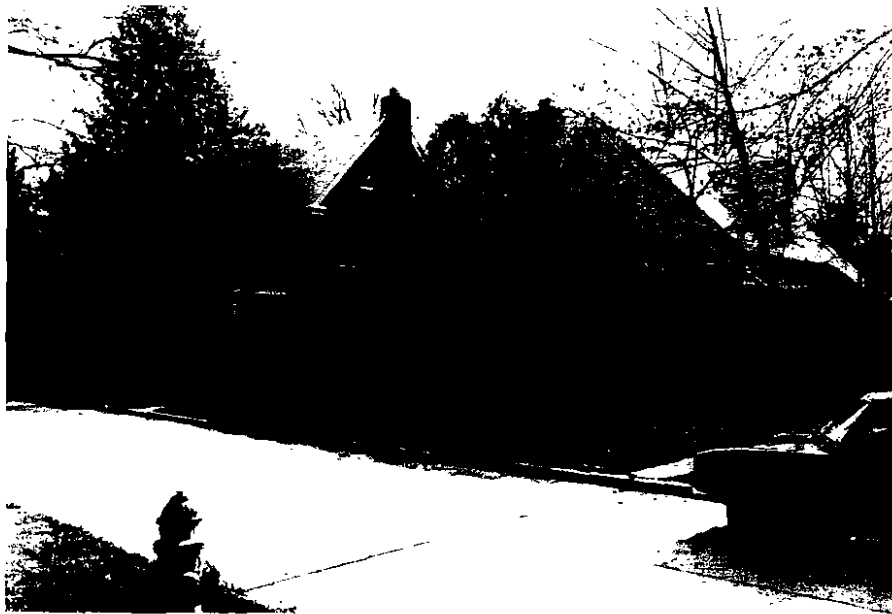
Bldg. 55

The flankers are oriented with their gable ends towards the street with two bays on the first floor (6/6 windows) and a frame upper half story above the beltcourse with small paired 6/6 windows in the gable peak. Frame entrance vestibules are on the inside elevations of the flankers facing the courtyard.

Classically detailed porches are attached to the rear elevations of the flankers and main blocks. The side elevations of the central block show stepped external brick chimneys flanked by 4 round windows in the gable peaks.

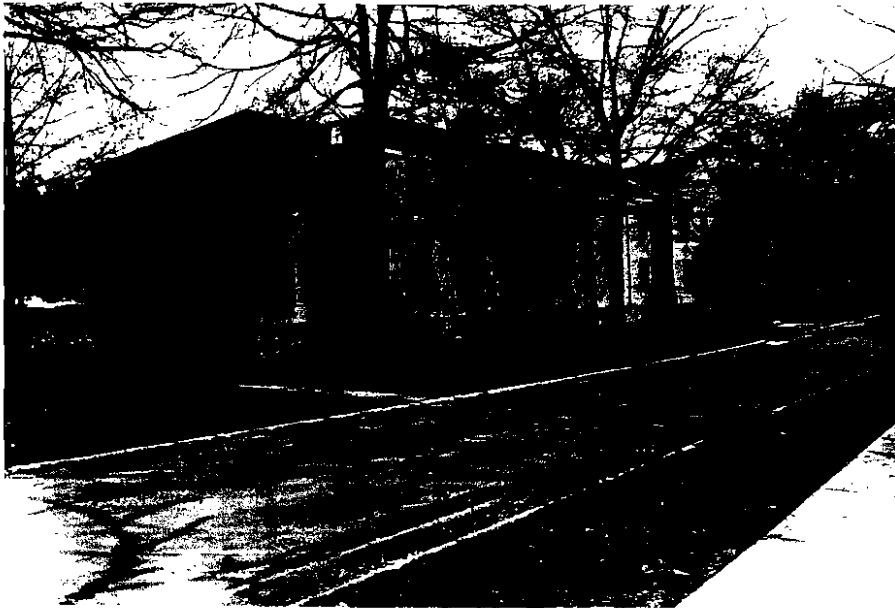
18. concrete foundation. All windows in the blocks are 8X8 casements with four light transoms. They are regularly placed between the 1/2" x 1/2" x 1/2" casements. The end on porch bays have 1/2" x 1/2" casements with six light transoms. The building corners are accentuated by stylized engaged pilasters and a plain concrete cornice extends around the building.

The projecting pavilions have central, glazed and paneled entrance doors with three light transoms in rubbed brick block surrounds with rope twist borders all set on concrete projections covered with tin shed roofs. The entrance doors are flanked by one window on either side and three windows are evenly placed across the second floor levels. Groups of eight tile vents appear in the gable peaks and are flanked by cornice returns.

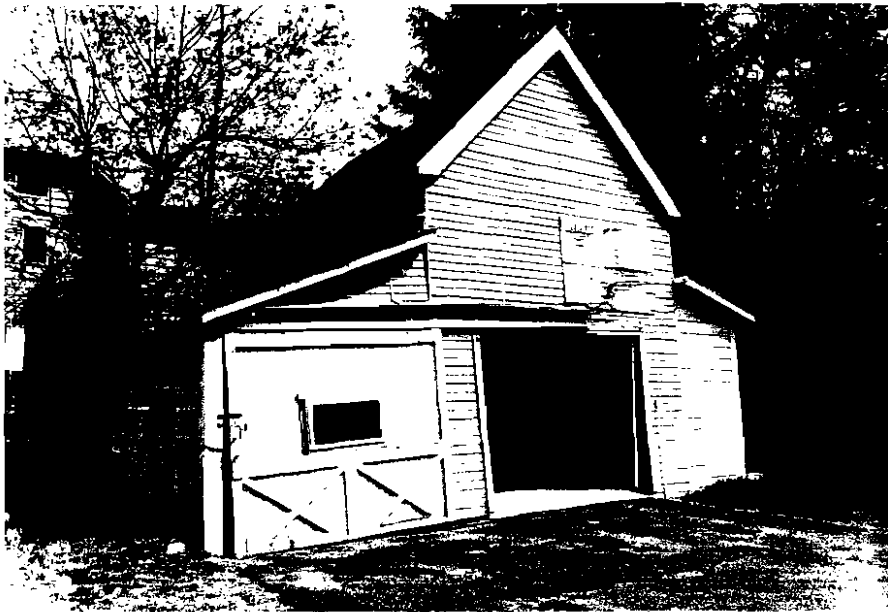
Barn/garage

18. ... is a gabled roof with ... supports and ... 1/1 window and entry door ... the porch is ... window in the cross gable. ... 1/1 window appears in the gable peak.

The building rests on a stone foundation and has a simple ... of wood. The south elevation shows paired 1/1 windows in the gable peak and a large single light window with transom on the first floor. The cross gable extends to the rear with 1/1 and 2/2 windows. Similar windows appear on the north elevation.

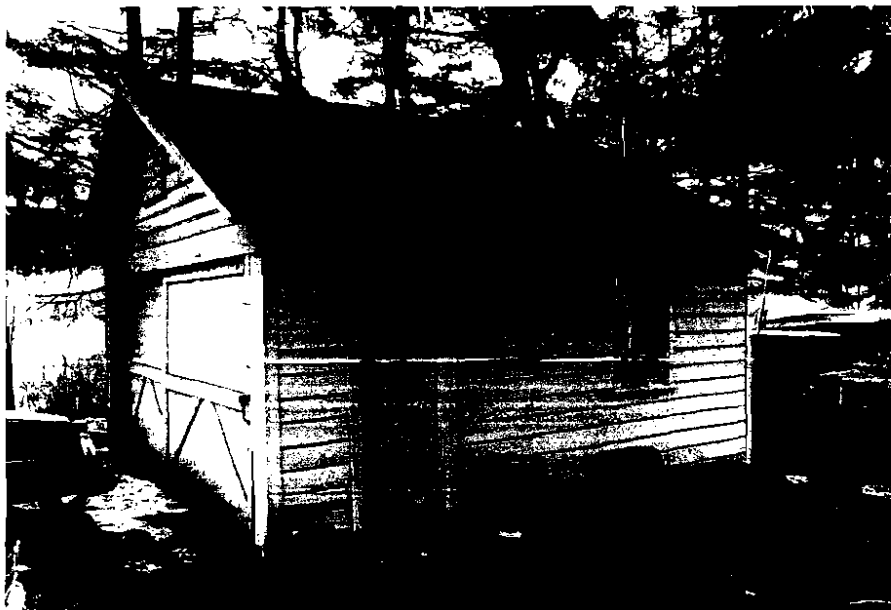
Gagoge

18. across the facade. The wall pattern in all elevations is coursed native sandstone. The upper half of the gable on the gable ends and the broad large window which fills the facade. Two brick chimneys project from either side of the broadly overhanging eaves at the ridge pole.
